## MISSOURI - KANSAS CITY RIVER BASIN

TEAL LAKE DAM  
AUDRAIN COUNTY, MISSOURI  
MO. 10082

### PHASE I INSPECTION REPORT NATIONAL DAM SAFETY PROGRAM.

Teal Lake Dam (MO-10082), Missouri - Kansas  
City River Basin. Audrain County, Missouri  
Phase I Inspection Report.

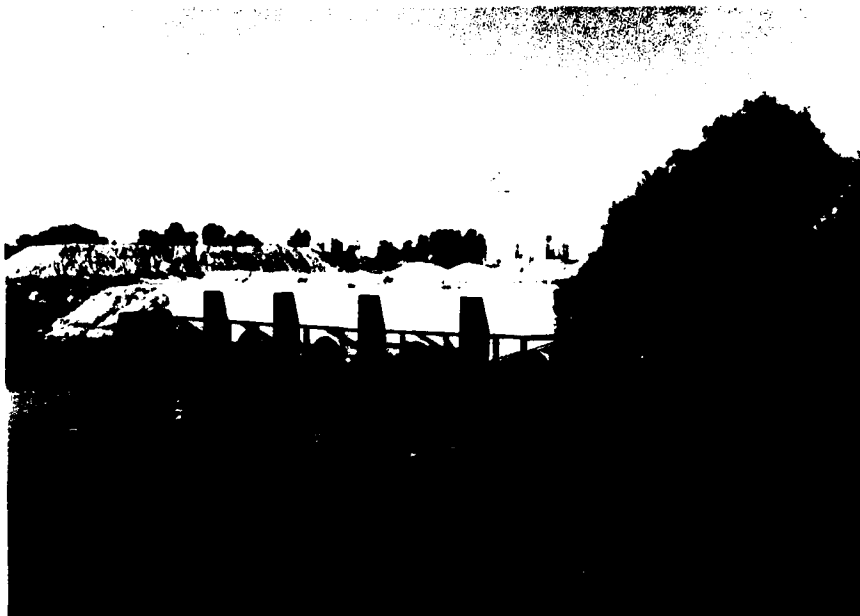
- Photo 1 - View of the upstream slope showing the entrance to 5 corrugated metal pipe-arches.
- Photo 2 - View of the top of dam.
- Photo 3 - View of the downstream slope showing the erosion on the slope and the outlet ends of the pipe-arches.

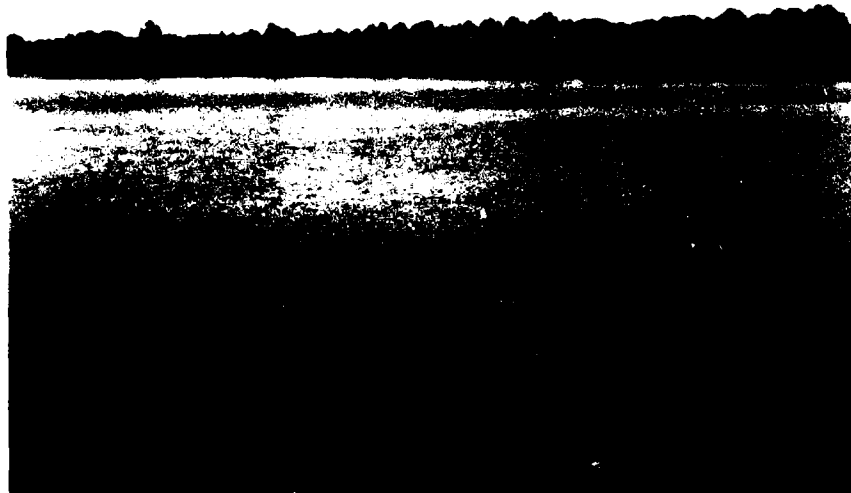
- Photo 12 - View of the reservoir and rim.
